SSME 0523 Test 902-772 Incident Investigation Summary

October 10, 2000

Space Shuttle Main Engine

SSME 0523, 902-772 Incident Investigation

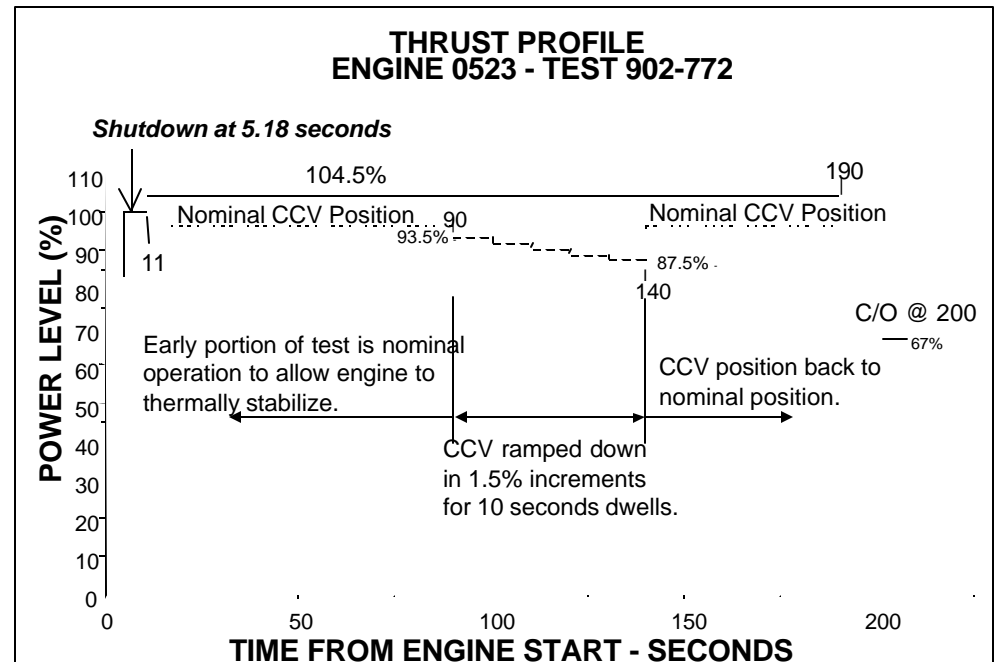
Engine Configuration (Hybrid Block I/II)

SSME 0523 engine configuration was a hybrid Block I/II configuration with standard throat Main Combustion Chamber (MCC) and a Pratt and Whitney HPFTP/AT.

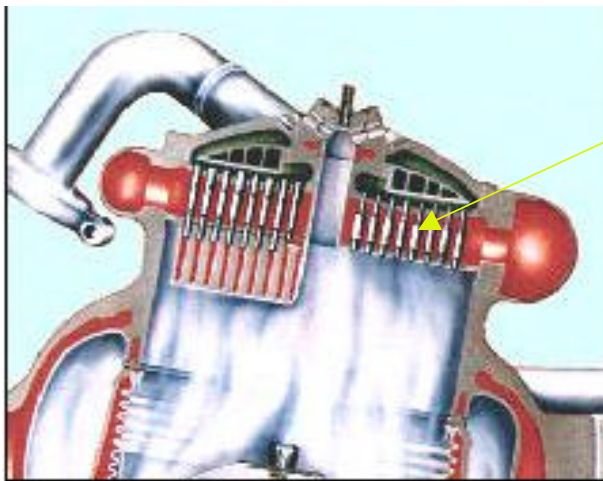
Fuel Cavity

Findings: Minor damage to the fuel preburner and standard throat main combustion chamber

Borescope inspection, destructive evaluation, and engine disassembly revealed gross contamination in the fuel cavity of the fuel and oxidizer preburners.

Contamination identified to be Permacel P-670 (LOX) tape.
