Space Shuttle Main Engine

SSME 0523, 902-772 Incident Investigation

Damage to the HPFTP/AT

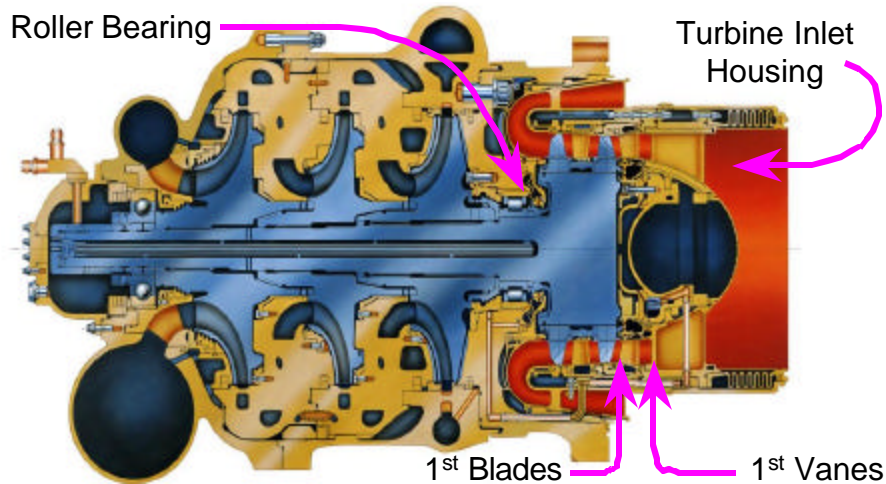
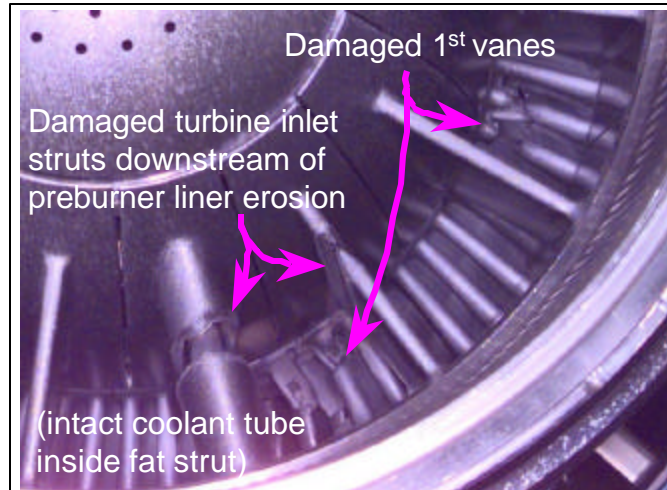
The majority of the damage occurred in the turbine-end. Damage incurred in the turbine downstream of the 1st blades resulted from impact. Pump-end hardware was damaged by rub and the loss of roller bearing support.

Turbine inlet struts and 1st vanes (stator) were eroded.

The airfoils of a segment of 1st vanes were eroded through, liberating that segment's inner platform to impact the 1st blades.

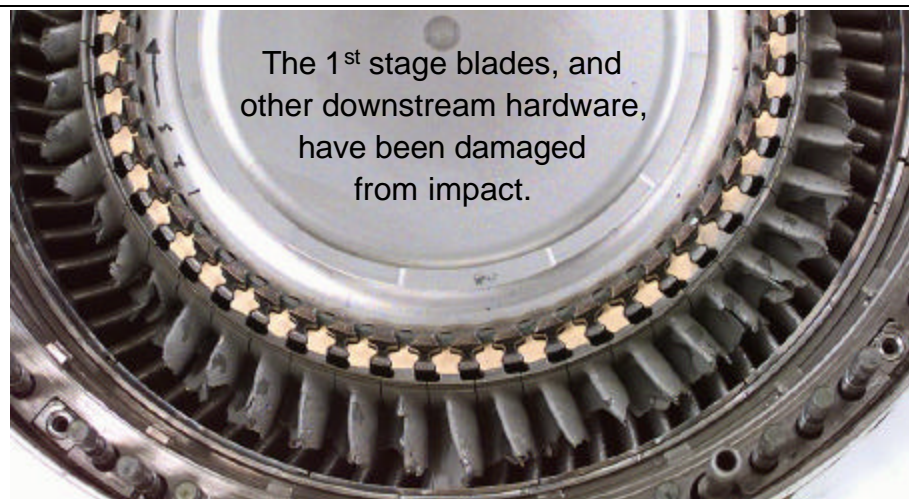
The 1st stage blades, and other downstream hardware, have been damaged from impact.

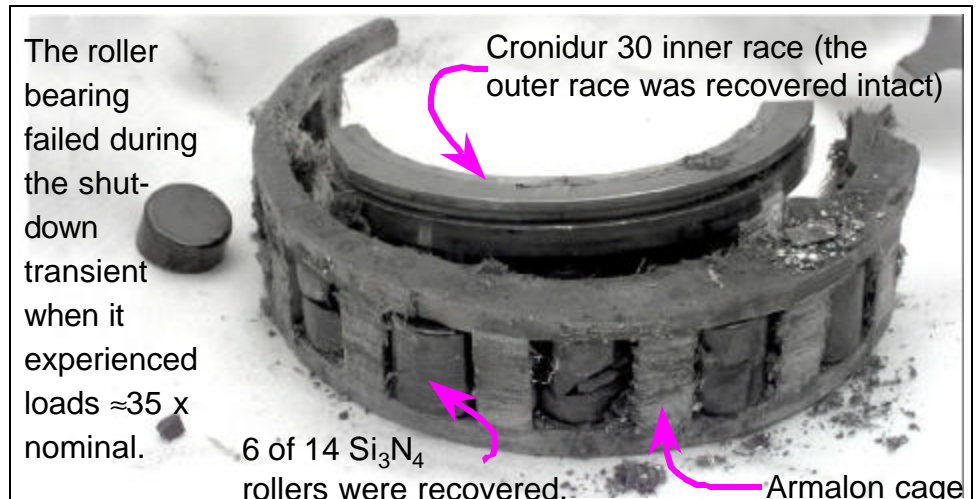
The roller bearing failed during the shut-down transient when it experienced loads $\approx 35 \times$ nominal.

Cronidur 30 inner race (the outer race was recovered intact)

6 of 14 Si_3N_4 rollers were recovered.

Armalon cage

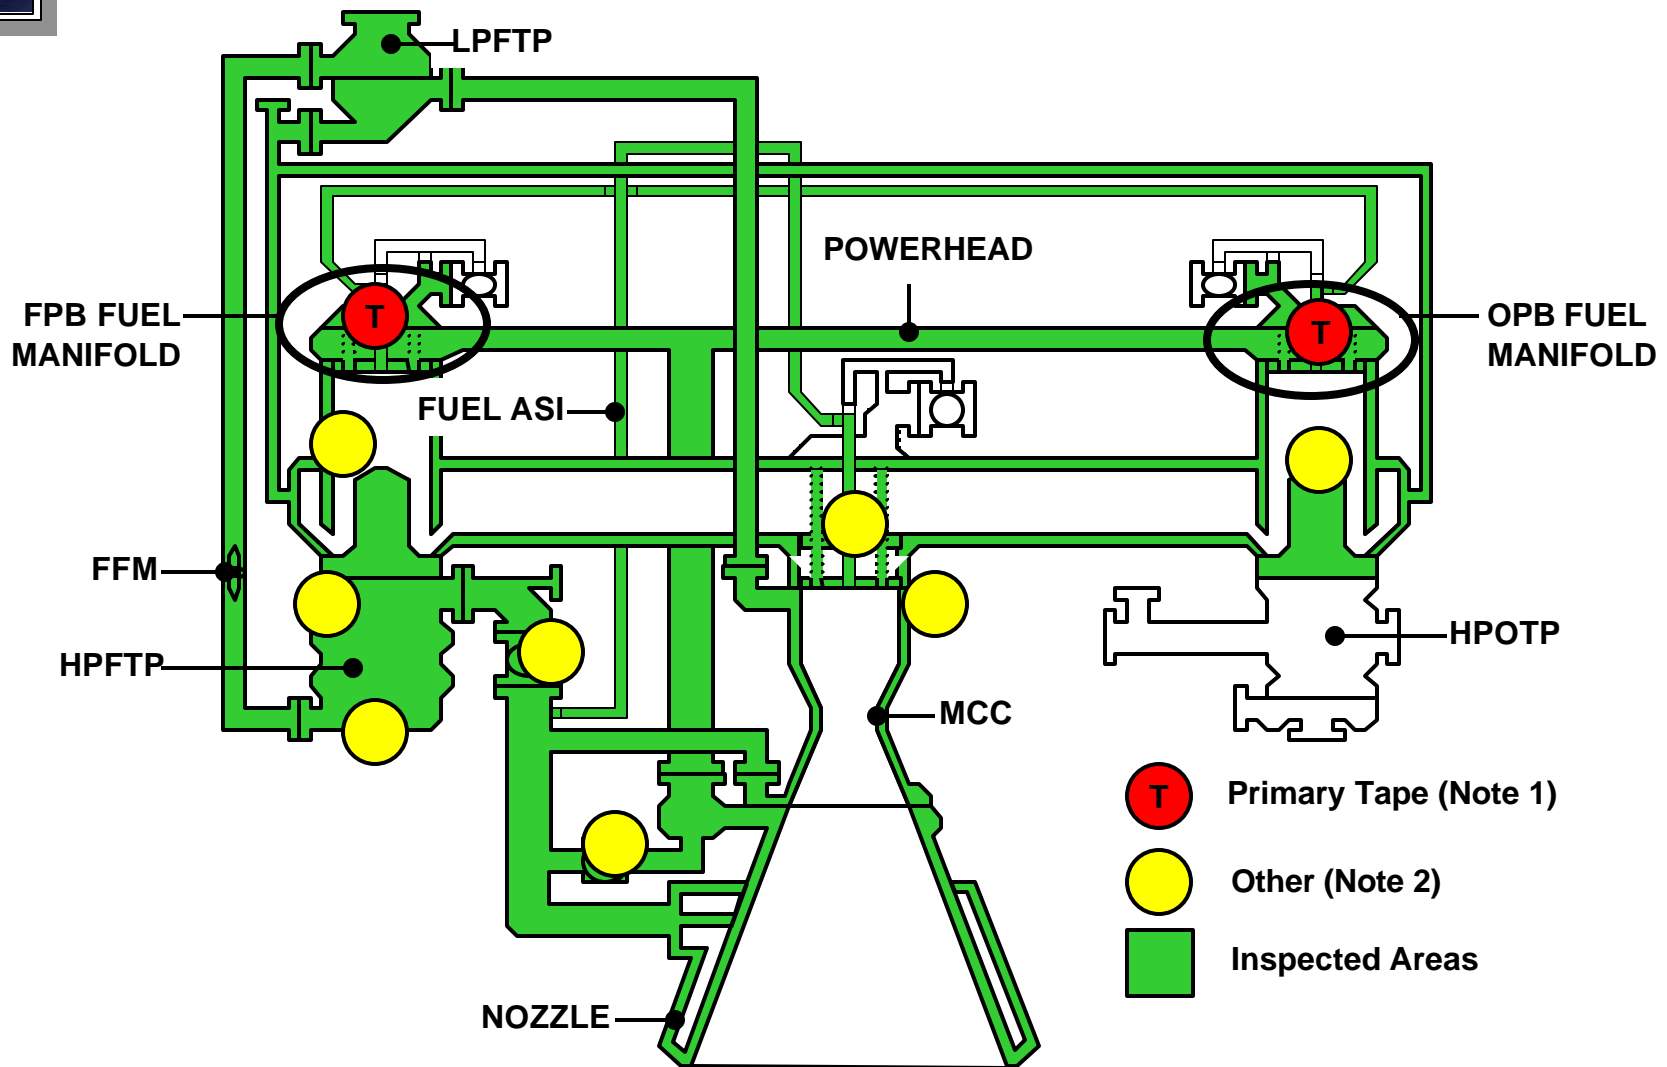
ENGINE 0523 FUEL SYSTEM CONTAMINATION POST 902-772

NOTE 1: Total amount of primary tape contamination estimated to be 24 square inches

NOTE 2: Other contamination consists of HPFTP/AT debris generated during the failure and insignificant amounts of various debris normally found during disassembly

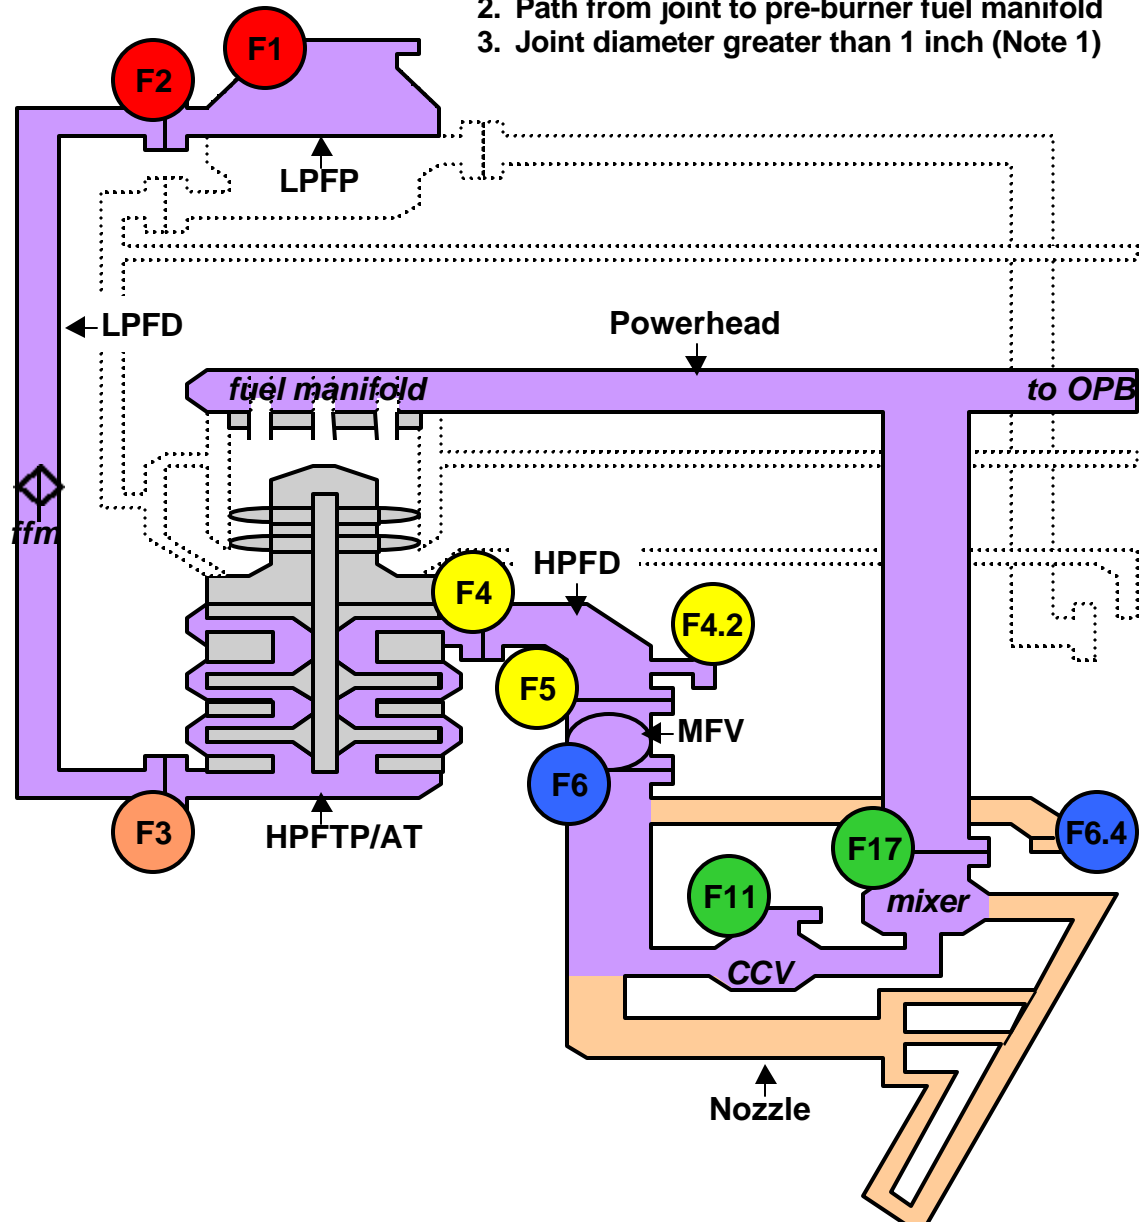
CANDIDATE POINTS OF ENTRY FOR ENGINE 0523 TAPE CONTAMINATION

● HIGH	Clear Path to Manifolds
● MEDIUM	No MCC/Noz Tape Debris
● LOW	No MCC/Nozzle Tape Debris after Engine Chill (NOTE 2)
● LOWER	No HPFP Tape Debris, & No MCC/Nozzle Tape Debris after Engine Chill (NOTE 2)
● LOWEST	No FFM Tape Debris, No FFM Detection, No HPFP Tape Debris, & No MCC/Nozzle Tape Debris after Engine Chill (NOTE 2)

- CRITERIA**
1. Joint broken since last hot-fire
 2. Path from joint to pre-burner fuel manifold
 3. Joint diameter greater than 1 inch (Note 1)

NOTE 1: 24 square inches of tape forms a ball greater than 1" dia.

NOTE 2: Chilled tape is brittle and more likely to contaminate the MCC and Nozzle
