APOLLO BY THE NUMBERS

**A statistical reference
for the manned phase of
Project Apollo**

APOLLO 1

Apollo 1 Fire Summary

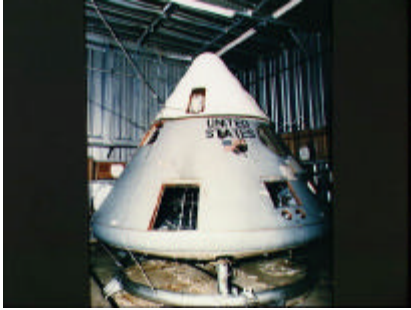
It was most likely that the fire began in the lower forward portion of the left-hand equipment bay, to the left of the command pilot, and considerably below the level of his couch.

Once initiated, the fire burned in three stages. The first stage, with its associated rapid temperature rise and increase in cabin pressure, terminated 15 seconds after the verbal report of fire. At this time, 23:31:19 GMT, the command module cabin ruptured. During this first stage, flames moved rapidly from the point of ignition, traveling along debris traps installed in the command module to prevent items from dropping into equipment areas during tests or flight. At the same time, Velcro strips positioned near the ignition point also burned.

Figure 4: Apollo 1 Command Module after fire (NASA S90-35348).

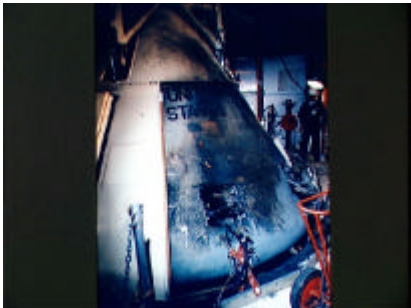
Figure 5: External view of fire damage to Apollo 1 Command Module (NASA S67-21295).

was exceeded late in the first stage of the fire and that rupture occurred at about 23:31:19 GMT. The point of rupture was where the floor or aft bulkhead of the command module joined the wall, essentially opposite the point of origin of the fire. About three seconds before rupture, the final crew communication began at 23:31:16.8 GMT. This communication ended shortly after rupture at 23:31:21.8 GMT, followed by loss of telemetry at 23:31:22.4 GMT.

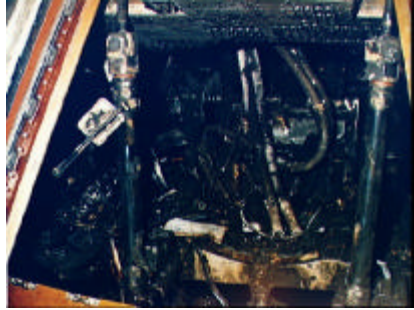
Figure 6: Internal view of fire damage to Apollo I Command Module (NASA S67-21294).

Although most of the fire inside the command module was quickly extinguished because of a lack of oxygen, a localized, intense fire lingered in the area of the environmental control unit. This unit was located in the left hand equipment bay, near the point where the fire was believed to have started. Failed oxygen and water/glycol lines in this area continued to supply oxygen and fuel to support the localized fire that melted the aft bulkhead and burned adjacent portions of the inner surface of the command module heat shield.
