SSME 0523 Test 902-772 Incident Investigation Summary

October 10, 2000

Space Shuttle Main Engine

SSME 0523, 902-772 Incident Investigation

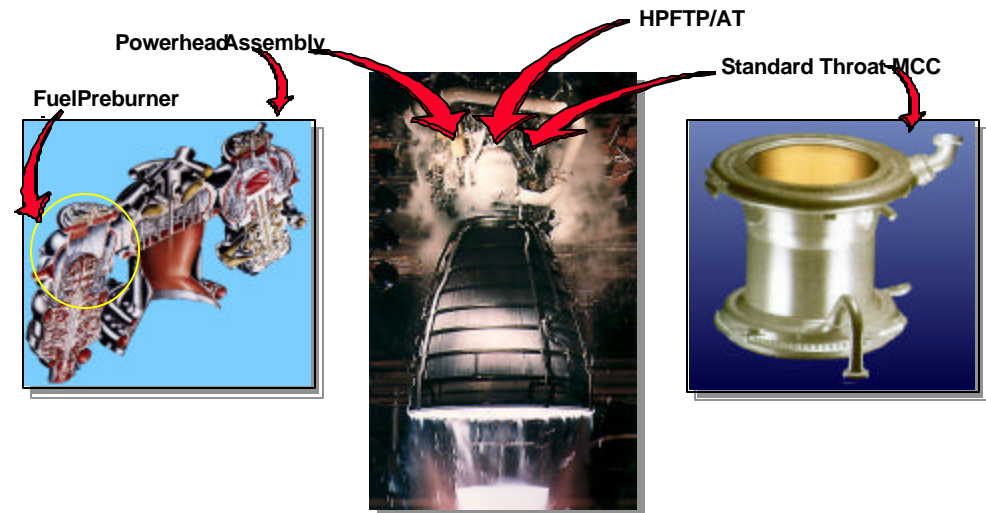
Engine Configuration (Hybrid Block I/II)

SSME 0523 engine configuration was a hybrid Block I/II configuration with standard throat Main Combustion Chamber (MCC) and a Pratt and Whitney HPFTP/AT.

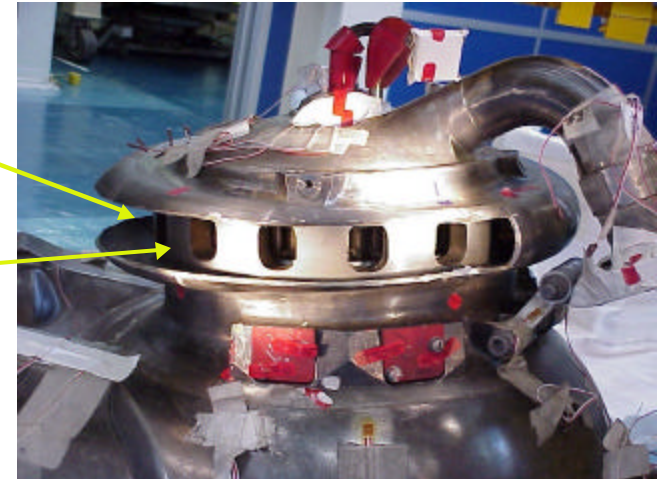
Window
4
and
5

Borescope inspection, destructive evaluation, and engine disassembly revealed gross contamination in the fuel cavity of the fuel and oxidizer preburners.

Contamination identified to be Permacel P-670 (LOX) tape.
